INSTALLING THE CLAM- SHELL DOOR FRAME

By Emily Rae Schutte and Kristi A. Dietz, AHC

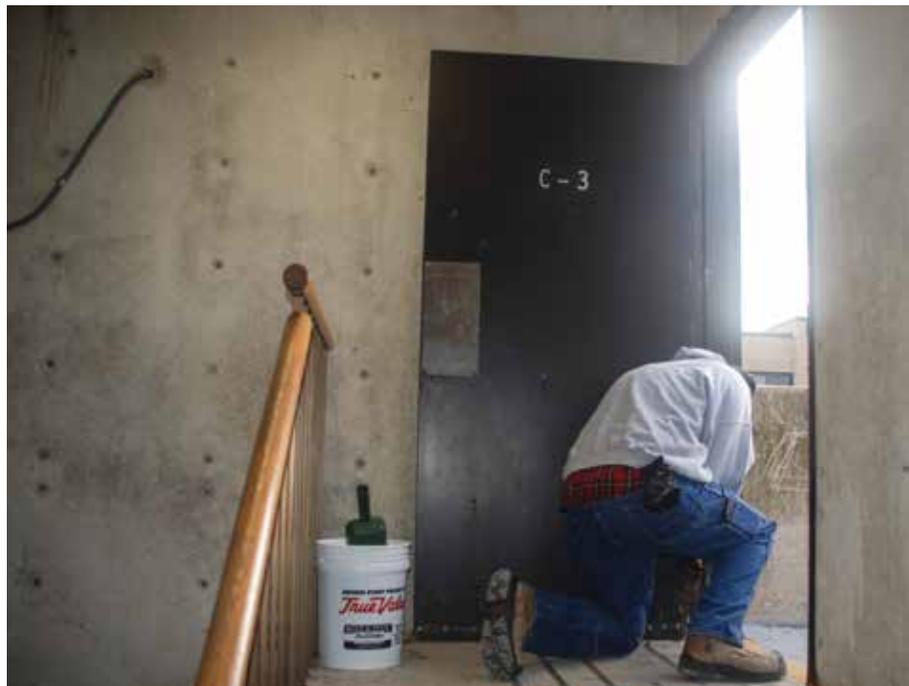
Besides location, other issues with the existing frame had to be taken into consideration before choosing the clamshell. There was significant rusting at the base of the frame, due to salt tossed at the exterior door during icy Wisconsin conditions. It was critical to ensure the clamshell solution did not just “cover up” the current problem only to create more issues down the road.

Interior before

Prior to installing the clamshell frame, LaForce’s worker removed the rusted portions of the frame, up to about two feet from the base. And at the end of the installation, he took care to complete all finish work, such as applying caulk and paint to the fasteners.

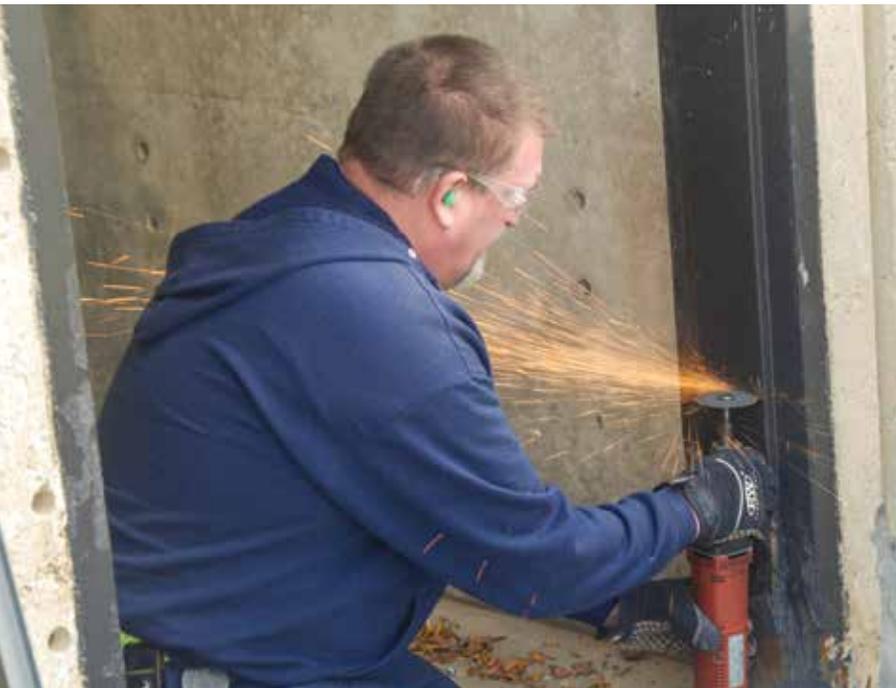
Previous frame rust removal

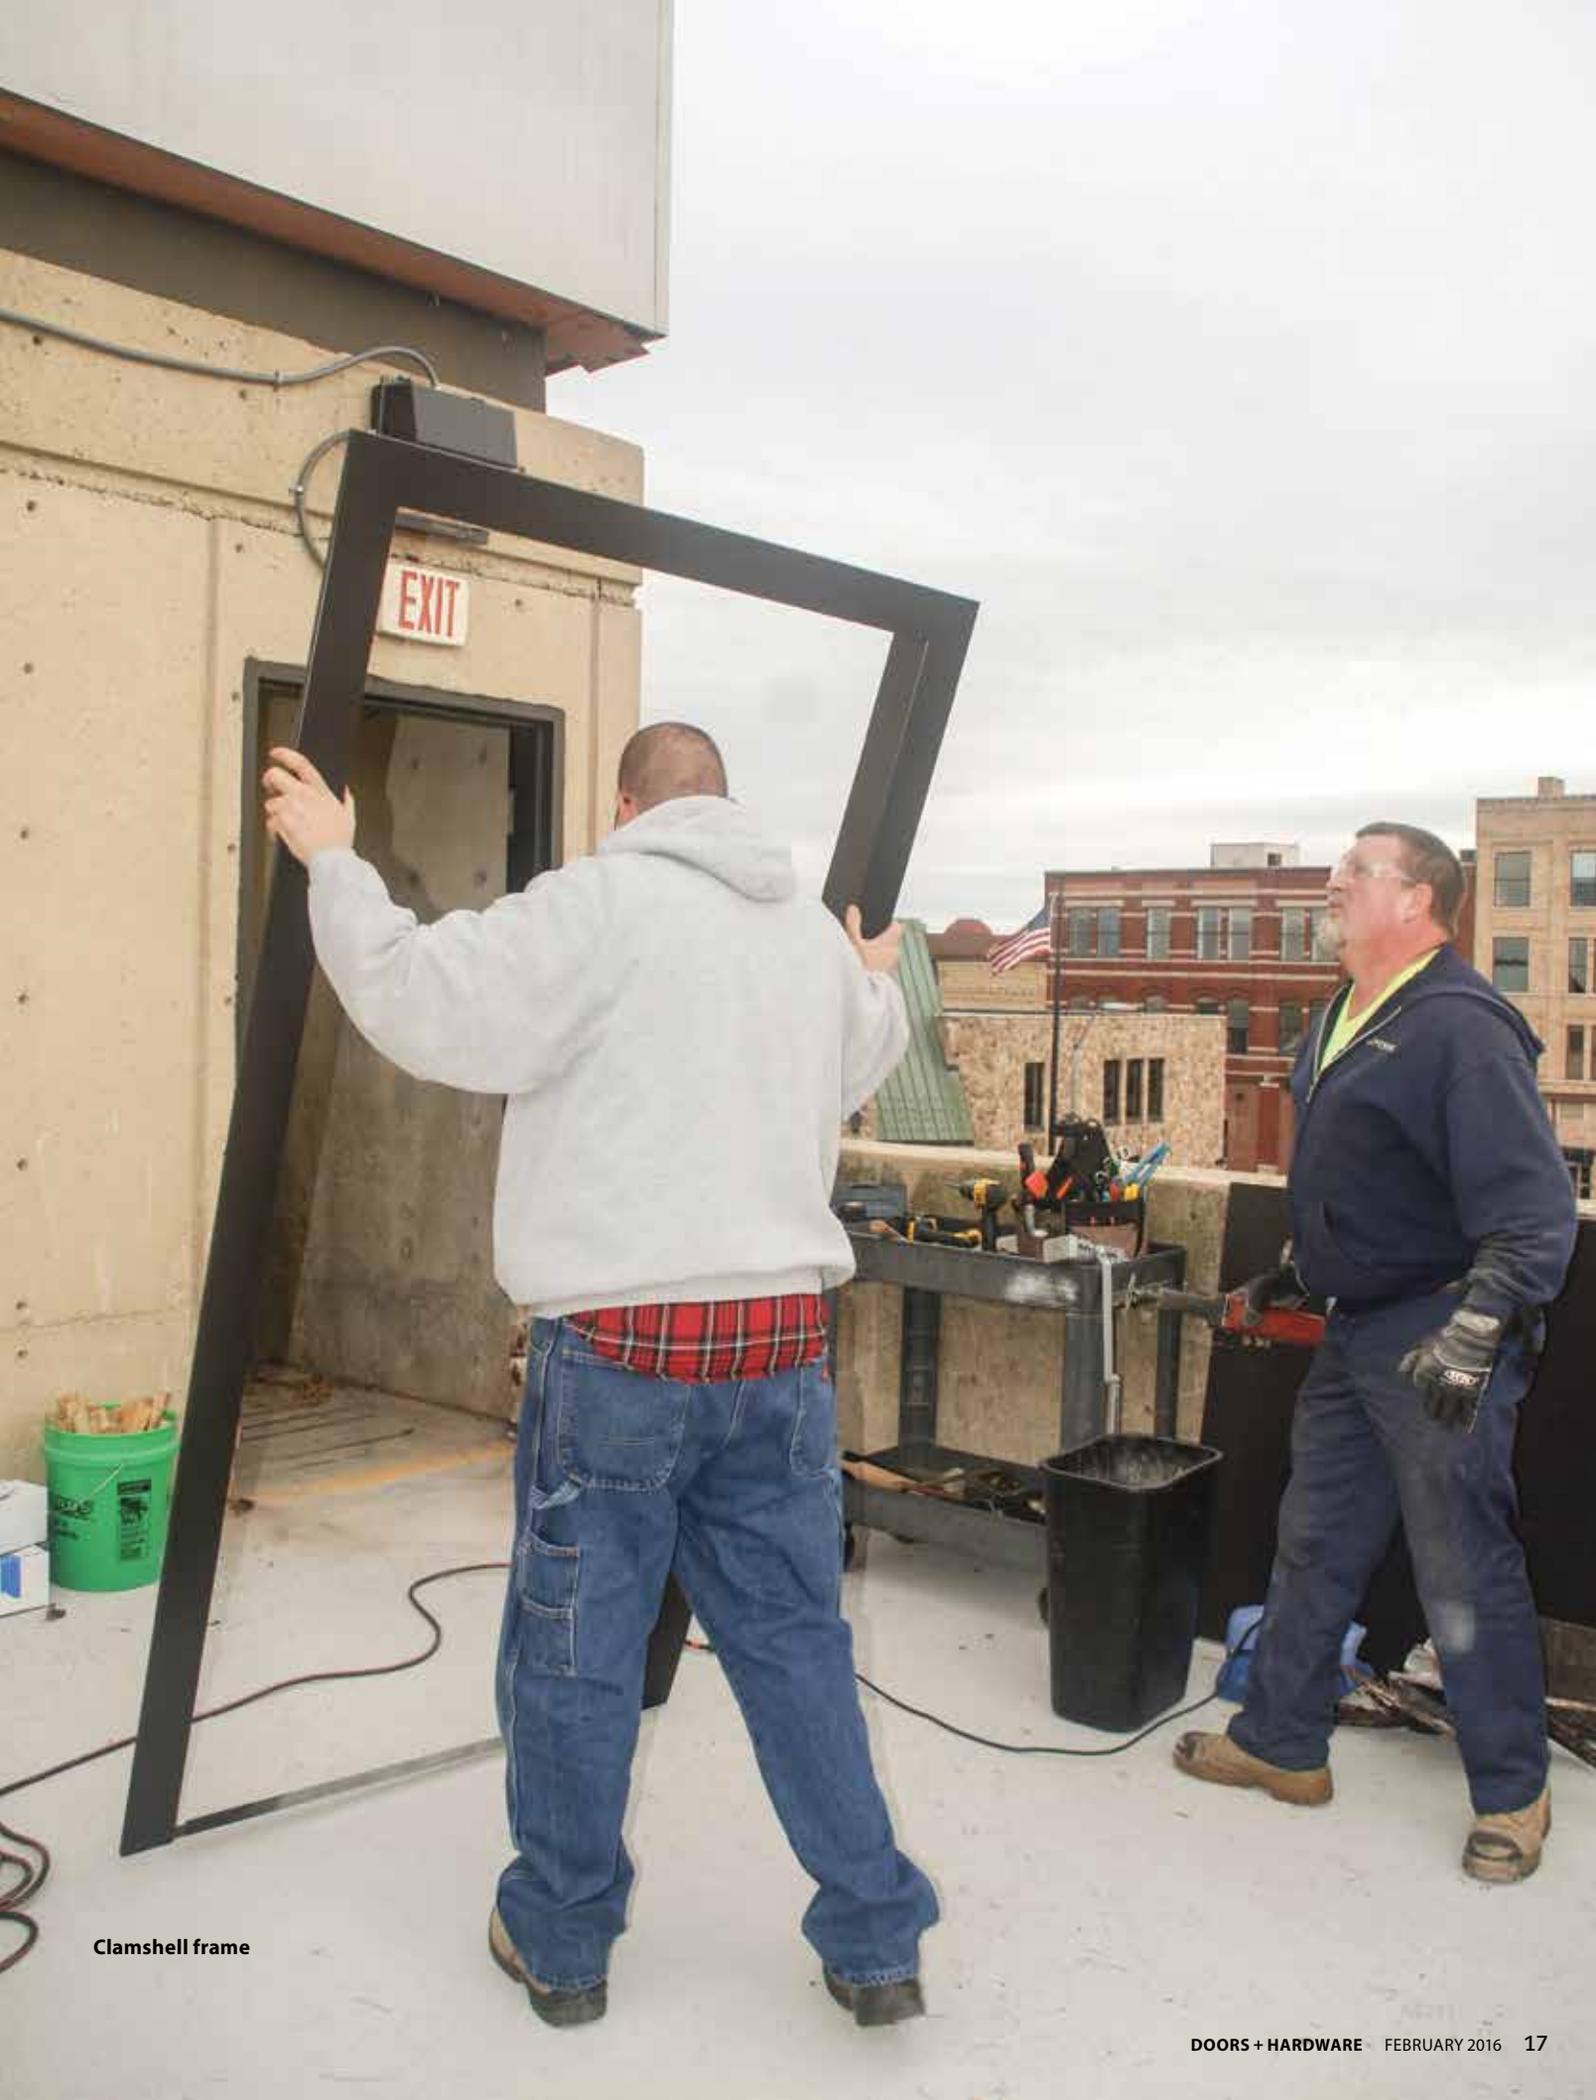
A clamshell frame, also known as a split retrofit frame, wraps around the existing hollow metal frame and is welded and/or screwed into place. Clamshell frames may also wrap existing wood frames, especially in situations where a very old frame needs to be preserved in order to save the integrity of the wall. It has several advantages:

Clamshell frame
